Proposed Emissions Modification, Part A: EA288 GEN3 MY 2015
Test Group FVGAV02.0VAL
Automatic and Manual Transmissions

Repair Instructions

August 2nd, 2016

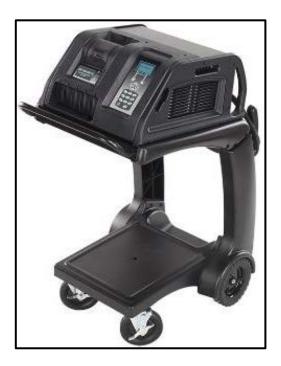
- VAS6150C Diagnostic Tester (or equivalent)
- VAS5054A Remote Diagnosis Head (or equivalent)

GRX3000VAS – Battery Tester/Charger (or equivalent)

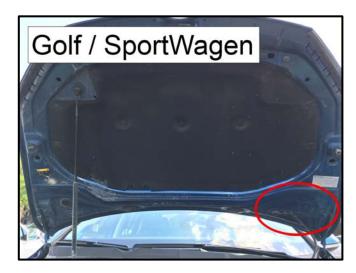
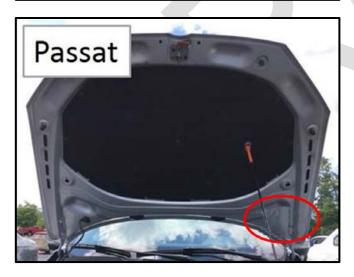
- Open the hood.
- Clean the surface where the label is to be installed <circle>.
- Install the supplemental Vehicle Emissions Control Information label, 03L 010 005 J, in the location shown <circle>.

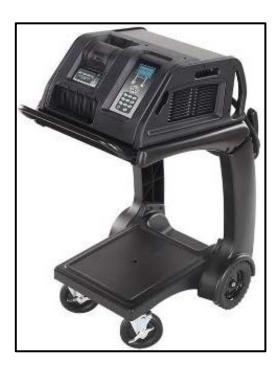
- VAS6150C Diagnostic Tester (or equivalent)
- VAS5054A Remote Diagnosis Head (or equivalent)

• GRX3000VAS – Battery Tester/Charger (or equivalent)

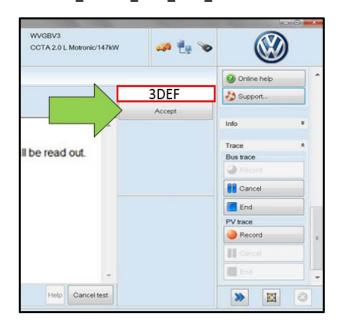
- Enter "3DEF" <as shown>.
- Select "Accept" <arrow>.

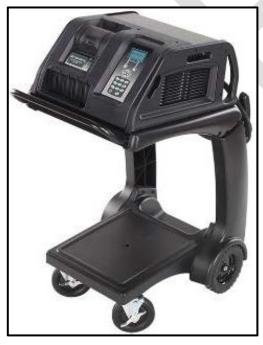
- VAS6150C Diagnostic Tester (or equivalent)
- VAS5054A Remote Diagnosis Head (or equivalent)

GRX3000VAS – Battery Tester/Charger (or equivalent)

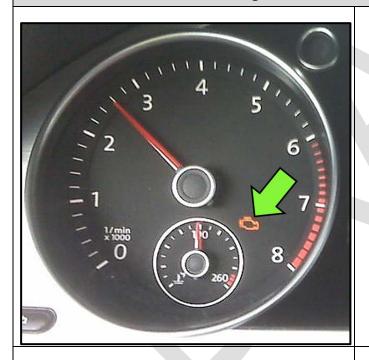
- Check for illumination of the MIL <arrow>.
  - If MIL is illuminated, STOP, create a VTA ticket and contact the Volkswagen Technicians Helpline.
  - If MIL is not illuminated, continue work procedure.

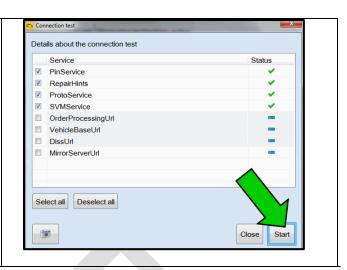
✓ Start a connections test <arrow> and verify that all connections pass.

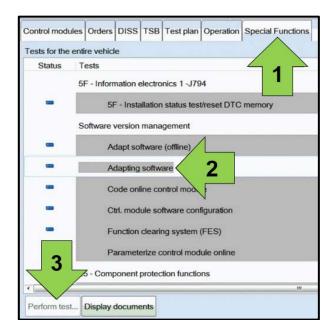
- Open the hood.
- Open the battery cover.
- Attach the GRX3000VAS Tester/Charger (or equivalent) to the vehicle battery.
- Switch the ignition on.
- · Apply the parking brake.
- Switch the headlights off.
- Connect the VAS6150C Diagnostic Tester (or equivalent) to the vehicle.
- Start the ODIS program.
- Confirm that scan tool is communicating with the diagnostic head by USB <Green Arrow>.
  - o If the Bluetooth symbol is shown <Red Arrow> then disconnect the diagnostic head from the vehicle and reconnect the USB cable to the diagnostic head and then reattach to the vehicle.
- Upon ODIS startup, verify the "Diagnosis" operating mode is selected <as shown>.

Once the GFF scan is complete, select "Special functions" <arrow 1>, then "Adapting software" <arrow 2>, then select "Perform test" <arrow 3>.

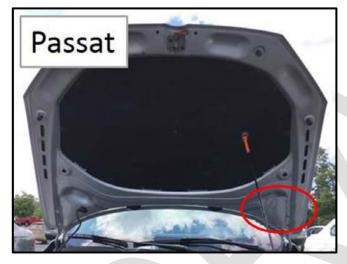
- The surface where the label is to be installed must be clean, dry, and free from oil residue prior to installing the label.
- Label must NOT cover any existing label(s).
- Label must be installed in locations shown.
- Photo documentation of label installed is required.

- Open the hood.
- Clean the surface where the label is to be installed <circle>.
- Install the supplemental Vehicle Emissions Control Information label, 03L 010 005 H, in the location shown <circle>.

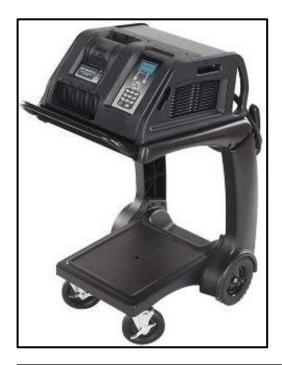
- VAS6150C Diagnostic Tester (or equivalent)
- VAS5054A Remote Diagnosis Head (or equivalent)

• GRX3000VAS – Battery Tester/Charger (or equivalent)

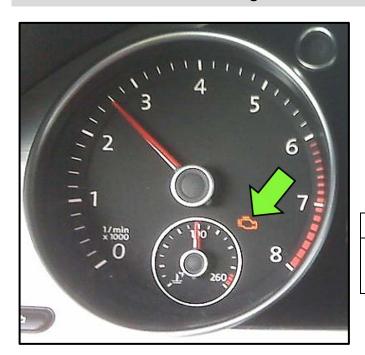
- Check for illumination of the MIL <arrow>.
  - If MIL is illuminated, STOP, obtain GFF diagnostic log, create a VTA ticket and contact the Volkswagen Technicians Helpline.
  - If MIL is not illuminated, continue work procedure.

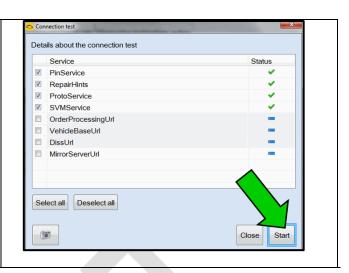
√ Start a connections test <arrow> and verify that all connections pass.

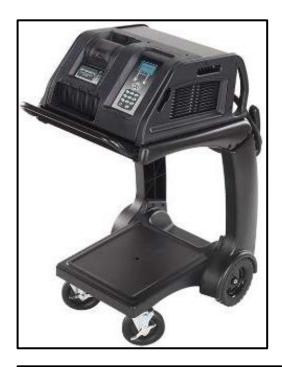
- VAS6150C Diagnostic Tester (or equivalent)
- VAS5054A Remote Diagnosis Head (or equivalent)

• GRX3000VAS – Battery Tester/Charger (or equivalent)

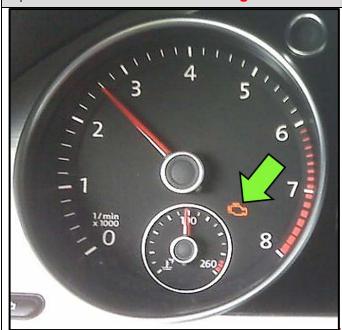
- Check for illumination of the MIL <arrow>.
  - If MIL is illuminated, STOP, obtain GFF diagnostic log, create a VTA ticket and contact the Volkswagen Technicians Helpline.
  - If MIL is not illuminated, continue work procedure.

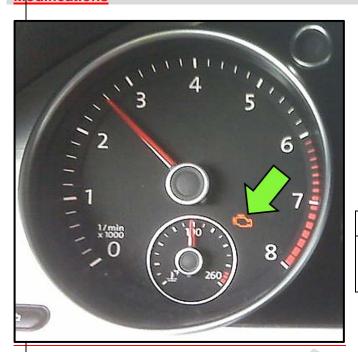
- Check for illumination of the MIL <arrow>.
  - o If MIL is illuminated, STOP, obtain GFF diagnostic log, create a VTA ticket and contact the Volkswagen Technicians Helpline.
  - o If MIL is not illuminated, continue work procedure.

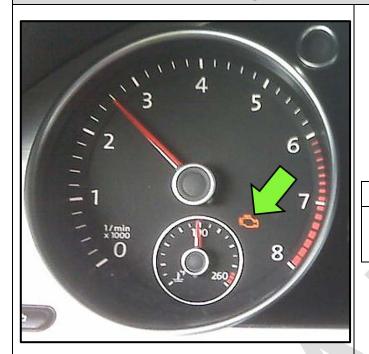
- Check for illumination of the MIL <arrow>.
  - If MIL is illuminated, STOP, create a VTA ticket and contact the Volkswagen Technicians Helpline.
  - If MIL is not illuminated, continue work procedure.

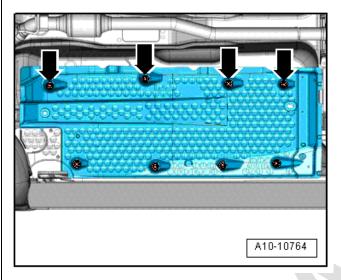
- Open hood.
- · Raise vehicle on hoist.
- Unscrew nuts -arrows- and pull underbody cladding down slightly.

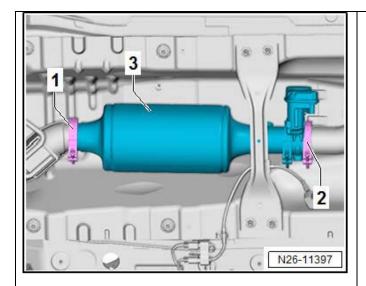
Loosen clamps -1- and -2- and remove NOx storage catalytic converter together with exhaust door control unit -J883-.

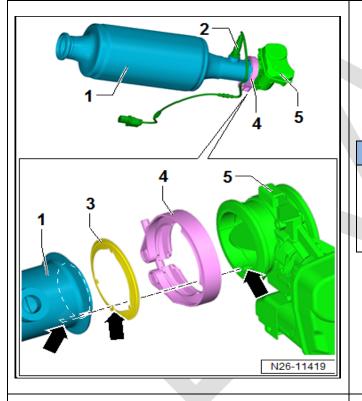
- Screw new oxygen sensor after catalytic converter -G130- -2- into new NOx storage catalytic converter -1- and tighten to 52 Nm using socket, 22 mm -T10491-.
- Set new exhaust door control unit -J883- -5- with new seal -3- on NOx storage catalytic converter -1-. Note notches -arrows-.

Renew all clamps and seals. The clamps before and after the exhaust door control unit are narrower than the clamp connecting the particulate filter to the NOx storage catalytic converter. Ensure that they are correctly allocated.

- Position clamp 1K0 253 725 B -4- and tighten to 7 Nm
- Place NOx storage catalytic converter together with exhaust door control unit -J883- with new seals in installation position. Note notches at rear connection.
- Position all clamps -1- so that they will not collide with underbody.

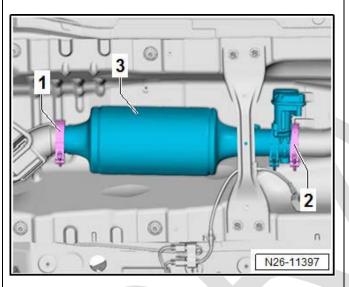
- Set clamp 1K0 253 725 B -2- in place and engage and torque to 7 Nm.
- Set clamp 1K0 253 725 -1- in place and engage. Then tighten to 7 Nm.

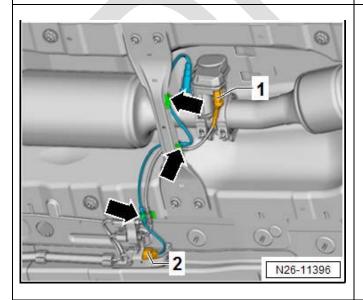
- Connect »brown« connector for oxygen sensor after catalytic converter -G130- -2- and attach to bracket.
- Push connector -1- onto exhaust door control unit. Secure lines in retainers -arrows-.

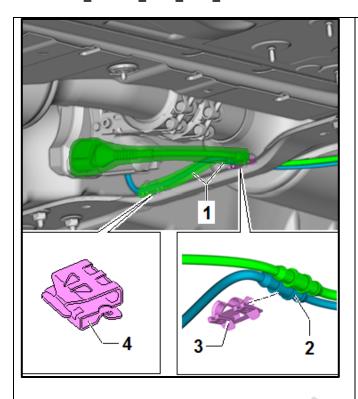
- Wrap new heat insulation mats -1- around wiring and close fasteners.
- Place wires -2- in clips -3- and -4-.

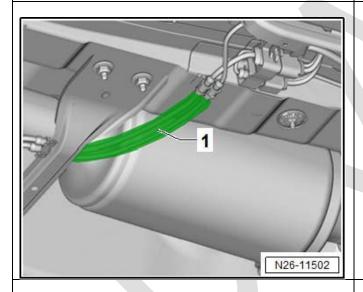
Wrap new heat insulation mats -1- around wiring and close fasteners.

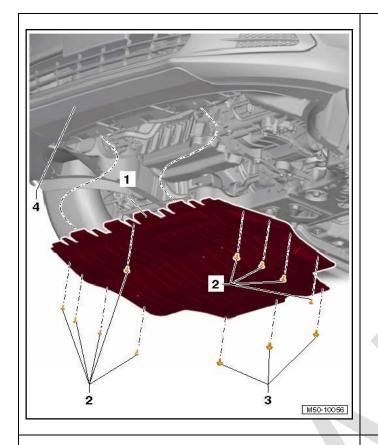
- Remove bolts -2- and -3-.
- Pull noise insulation -1- back, out of front bumper cover -4-.

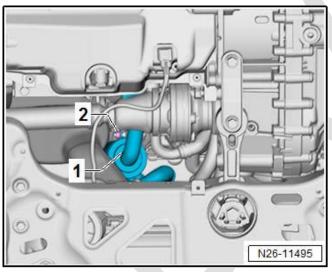
- Remove nut -2- from exhaust gas recirculation filter -1- from below using 13 mm ratchet box wrench (e. g. Snap-on OEXRM13).
- Wrap tape around the tip of a long screwdriver (e.g. Snap-on SDD162 No.2).

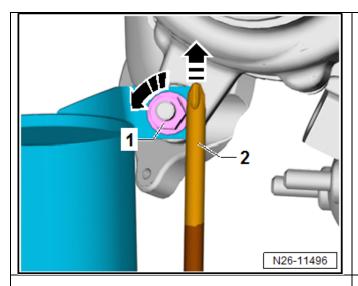
Apply screwdriver -2- on side of nut -1- and unscrew nut while simultaneously pressing up on nut.

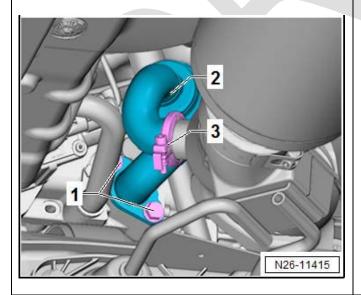
- Set new exhaust gas recirculation filter -2- with new seals in place, screw in bolts -1- and tighten to 9 Nm.
- Position clamp -3- and tighten to 3.5 Nm.

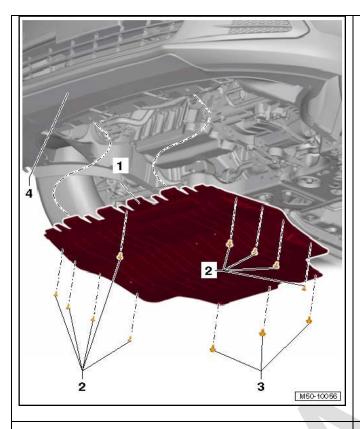
- Push noise insulation -1- forward into front bumper cover -4-.
- Screw in bolts -2- and new bolts -3- and tighten as follows:
  - o Bolt -2-: 2 Nm
  - Bolt -3-: 6 Nm (renew)

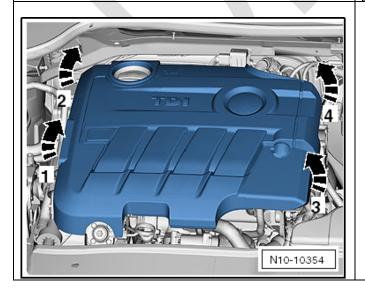
• Pull engine cover up out of fastening elements near –arrows– in order shown. To do this, grip as far as possible beneath engine cover.

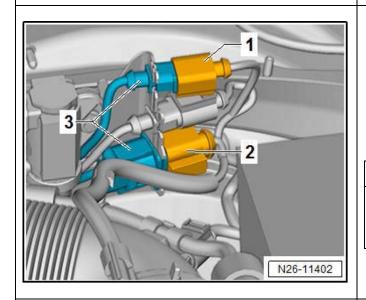
- Disconnect »orange« connector for exhaust gas temperature sender 2 -G448- -1- and »black« connector for oxygen sensor -G39- -2- on plenum chamber bulkhead.
- Remove wiring -3- from retainer and move clear.

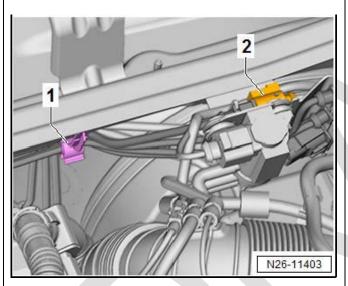
- Disconnect »brown« connector for exhaust gas temperature sender 3 -G495- -2- (secured behind bracket).
- Thread lines out of brackets -1- on plenum chamber bulkhead and on turbocharger.

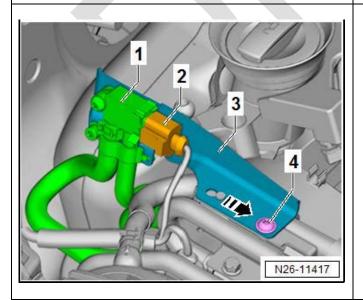
- Pull connector -2- off differential pressure sensor -G505- -1-.
- Remove securing bolt -4-, remove bracket -3with differential pressure sender -G505- -1- in direction of arrow- and move aside. Control lines remain connected.

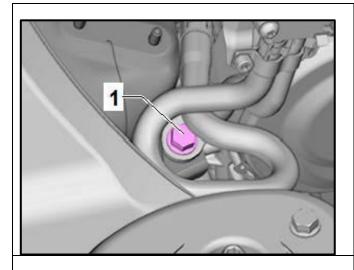
• Unscrew securing bolt -1- on upper bracket for particulate filter.

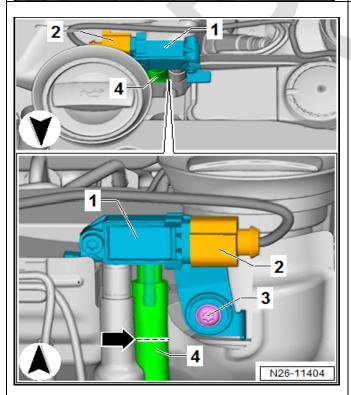
- Pull connector -2- off exhaust pressure sensor 1 -G450- and remove securing bolt -3-.
- Cut control line -4- to exhaust gas recirculation cooler with an appropriate tool (e.g. utility knife) at the line -arrow- indicated in figure.
- Move bracket with exhaust pressure sensor 1 -G450- aside (control line to particulate filter remains connected).

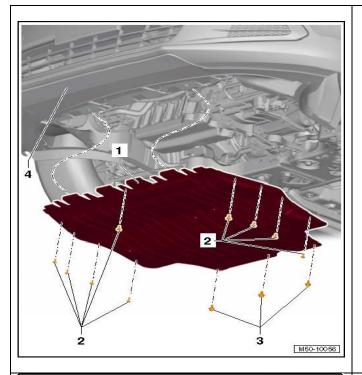
- Remove bolts -2- and -3-.
- Pull noise insulation -1- back, out of front bumper cover -4-.

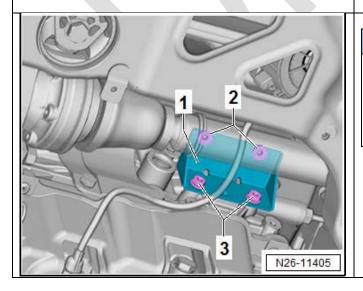
Unscrew securing nuts above bracket -2- with ratchet wrench -T10384-. In some cases, the bracket cannot be removed until the particulate filter has been detached.

Remove nuts -2- and -3- and remove lower bracket for particulate filter -1-.

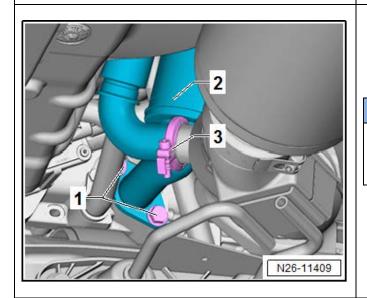
• Open clamp -3- and remove it.

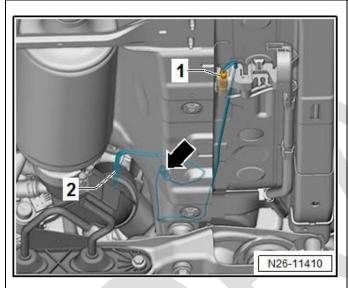
- Disconnect »brown« connector for oxygen sensor after catalytic converter -G130- -2-.
   Remove plug from retainer.
- Open fasteners on heat shield, pull connector -1off exhaust door control unit -J883- and thread wiring out of retainers -arrows-.

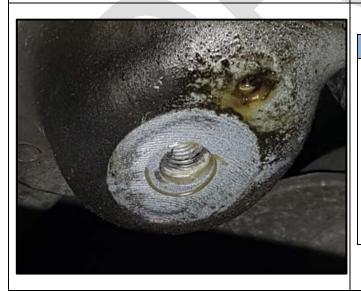
To fix the position of the subframe, the locating pins -T10096- must be screwed one at a time into positions -1-, -2-, -3- and -4-.

The locating pins -T10096- may be tightened only to max. 20 Nm, or the threads of the locating pins will be damaged.

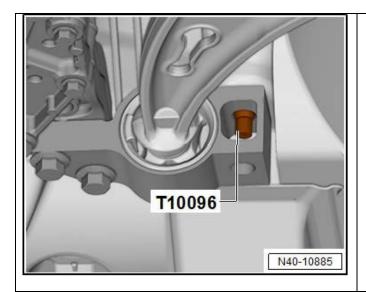
When installing the subframe locating pins -T100096-, it is possible to damage the subframe mount threads due to the normal variance in alignment. Damage to the subframe mount threads would be an extensive, body-shop repair that is not covered under this action.

Only use hand tools for this process. If the locating pins bind, they should be backed out, threads cleaned and restarted.

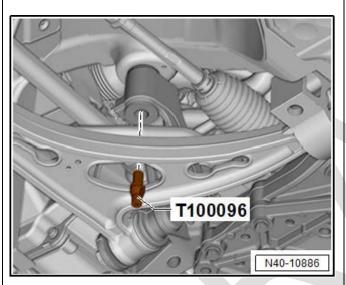
One at a time, remove securing bolts on mounting bracket and replace them with locating pins -T10096- on both sides. Tighten locating pins to 20 Nm.

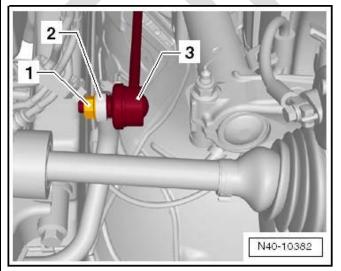
• Removed bolts -2- and -3- for pendulum support -1- from gearbox.

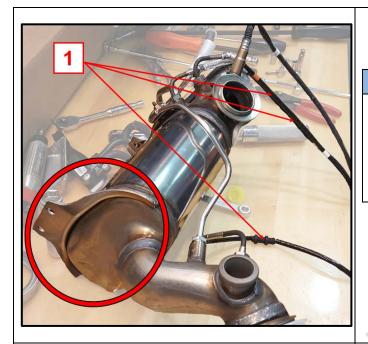
When installing the exhaust gas temperature senders to the DPF, it is possible to install the sensors <1> in the wrong locations. Sensors installed in the wrong positions will not function properly. Pay attention to the sensor color coding <circle> when installing sensors into the DPF.

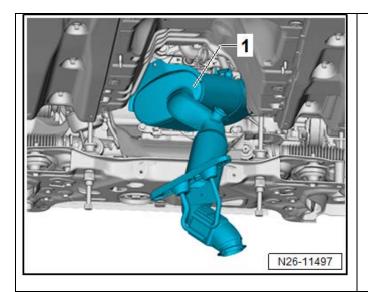
#### Installing particulate filter

Danger of damaging flexible joint between particulate filter and NOx storage catalytic converter. When removing and installing:

- Do not bend flexible joint more than 10°.
- Install flexible joint free of tension.
- Take care not to damage wire mesh on flexible joint.
- The flexible joint must be secured with transportation lock -T10404- to prevent overstretching.
- Always hold the particulate filter by the heavy casing when transporting or handling it.
  - Loosen nut -arrow- for bracket -1- on top of cylinder head a few turns.

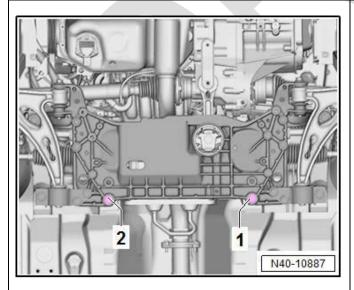
- Raise subframe about 5 cm, screw in bolt -1- and tighten to 3 Nm.
- Carefully raise subframe to installation position taking locating pins into consideration.

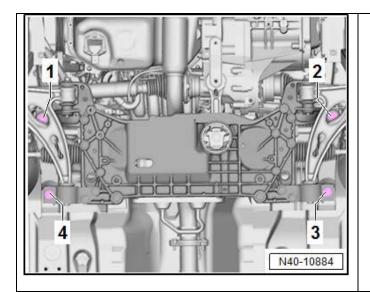
Remove spindles 3346/2, screw in new bolts (M12 x 110 mm) at positions -1- and -2-, tighten to 50 Nm and turn an additional 120°.

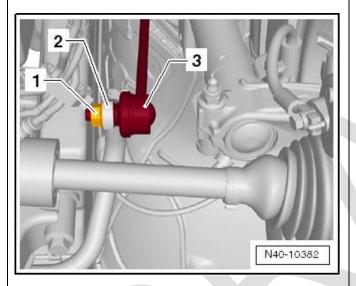
- Remove locating pins one at a time and replace them with new bolts (M12 x 90 mm).
- Tighten bolts to 70 Nm and turn them 180° further.
- Take load off engine and gearbox jack -VAS 6931- and remove it from work area.

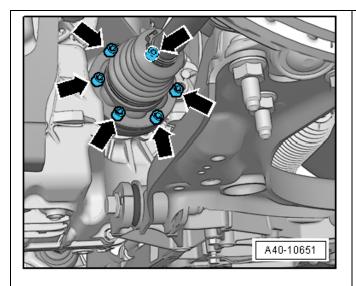
- Tighten bolts -arrows- securing exhaust system bracket to subframe to 23 Nm.
- Remove transport and protective packaging from flexible joint for particulate filter.

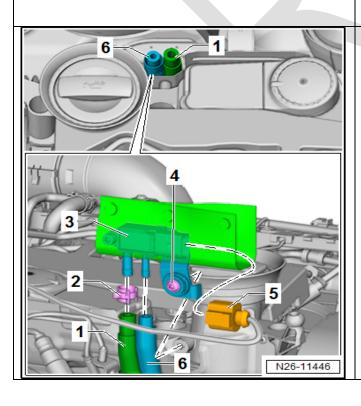
For greater clarity, exhaust pressure sensor 1 -G450is shown here from behind (perspective of plenum chamber bulkhead).

- 1 Remove bolt -1-.
- 2 Remove and dispose of old pressure sensor -
- 3 Insert new pressure sensor -2- into bracket 3-.
- 4 Screw in bolt -1- and tighten to 10 Nm.
- 5 Guide bracket with pressure sensor through openings in new heat shield -4-.

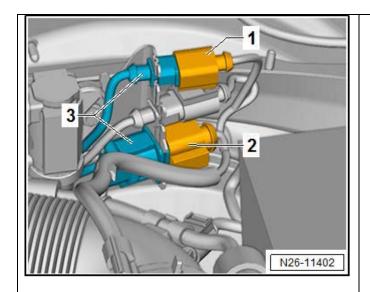
- Connect »brown« connector for exhaust gas temperature sender 3 -G495- -2- and secure behind bracket.
- Thread lines into brackets -1- on plenum chamber bulkhead and on turbocharger.

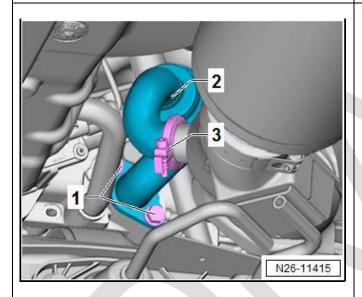
Connect »orange« connector for exhaust gas temperature sender 2 -G448- -1- and »black« connector for heated oxygen sensor -G39- -3- on plenum chamber bulkhead and secure wiring -3in retainer.

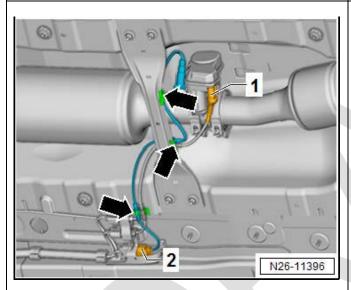
Set front tunnel cross-piece -1- in place, screw on hexagon nut -2- and tighten to 20 Nm.

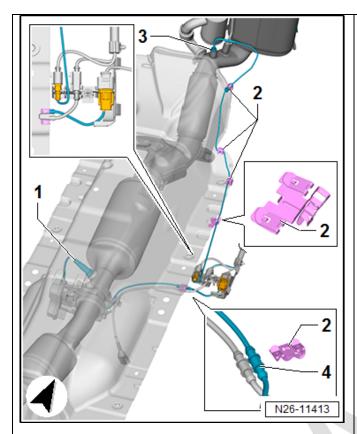
- Connect »brown« connector for oxygen sensor after catalytic converter -G130- -2- and attach to bracket.
- Push connector -1- onto exhaust door control unit. Secure lines in retainers -arrows-.

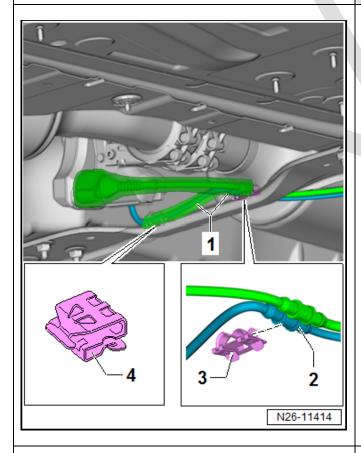
## Routing electrical wiring on underbody

Place electrical wiring from oxygen sensor after catalytic converter -G130- -1- and exhaust gas temperature sender 4 -G648- -3- in clips -2- on heat shield as shown. Connect connector and secure in bracket.

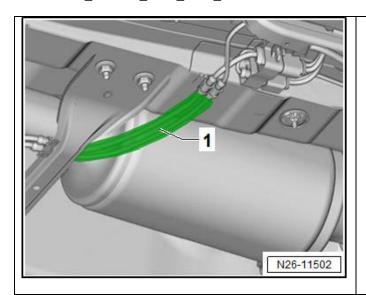
- Wrap new heat insulation mats -1- around wiring and close fasteners.
- Place wires -2- in clips -3- and -4-.

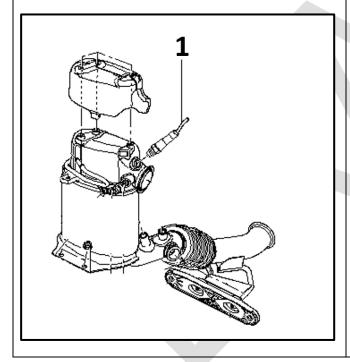
- If required by test plan results, loosen and remove the original Heated Oxygen Sensor -G39-<1> from Diesel Particulate Filter using the Ring Wrench 7-piece set -3337-.
- Install new Heated Oxygen Sensor -G39- <1> (part number 03L.906.262.B) into Diesel Particulate Filter using the Ring Wrench 7-piece set -3337- and torque to 52 Nm.

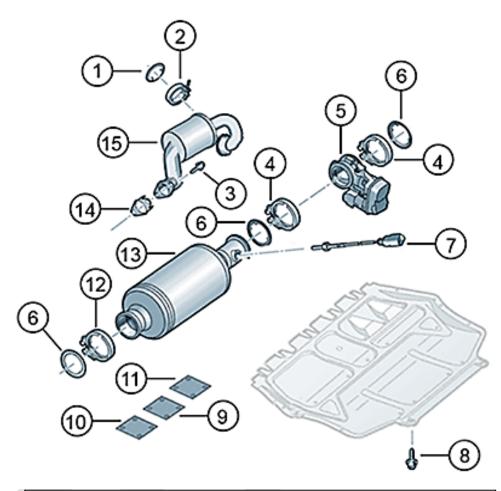
## 2.0L Base Kit 1 - 1K0.298.101.A (All MY Vehicles)

#	Part	Name	Quantity Required Per Vehicle
1	1K0253115AG	Seal	1
2	1K0253725F	Clamp	1
3	N10642103	Bolt (M8x25)	2
4	1K0253725B	Clamp (narrow)	2
5	1K0253691J	Exhaust door control unit -J883-	1
6	1K0253115AE	Seal	3
7	03L906262N	Oxygen sensor after catalytic converter -G130-	1
8	1K0825951	Bolt self-locking (M6x20)	3
8	WHT000729A	Bolt self-locking (M8x20)	3
9	1K0971461D	Heat shield (Cable for Exhaust door control unit –J883-)	1
10	1K0971461E	Heat shield (Cable for Oxygen sensor –G130-)	1
11	1K0971461F	Heat shield (Cable for Oxygen sensor and Exhaust door control unit)	1
12	1K0253725	Clamp	1
13	1K0254402AX	NOx storage catalytic converter	1
14	03G131547H	Seal	1
15	1K0253120B	Exhaust gas recirculation filter	1

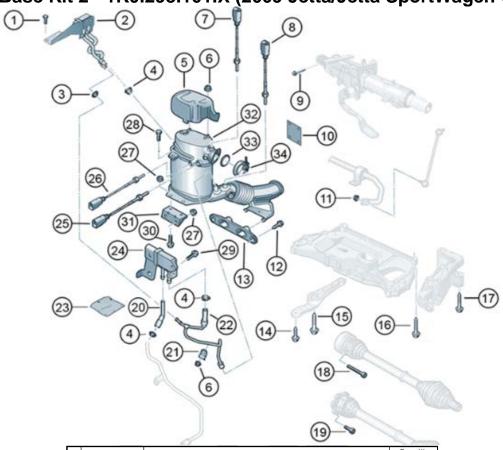
## 2.0L Base Kit 2 - 1K0.298.101.X (2009 Jetta/Jetta SportWagen Only)

#	Part	Name	Quantity Required Per Vehicle
1	N90737105	Bolt	1
2	1K0131552B	Differential pressure sender -G505-	1
3	3C0131483A	Spring clamp	3
4	4B0422379	Spring clamp	1
5	5N0131783	Heat shield	1
6	N02300215	Nut M6	4
7	03L906262B	Oxygen sensor -G39-	1
8	03L906088EG	Exhaust gas temperature sender –G648-	1
9	N01033513	Bolt for U-joint	1
10	5N0971461	Heat shield	1
11	N0150816	Nut	2
12	N10240003	Bolt (M8x32)	2
13	1K0253144BC	Exhaust system bracket	1
14	N91066101	Bolt (M10x35)	1
15	N91167101	Bolt (M10x75)	1
16	WHT000431A	Bolt M12x110	2
17	N91039802	Bolt M12x90	4
18	N90991102	Bolt (M10x52) - Manual Transmission	6
19	N90991002	Bolt (M10x23) - DSG Transmission	6
20	03G131525	Hose for control line	1
21	1K0131649	Retainer	1
22	1K0131552A	Control line	1
23	1K0971461C	Heat shield	1
24	076906051A	Exhaust pressure sensor 1 -G450-	1
25	03L906088T	Exhaust gas temperature sender – G448-	1
26	03L906088J	Exhaust gas temperature sender – G495	1

27	N01508315	Nut M8	4
28	N10653102	Bolt	1
29	N10456201	Bolt M6x25	1
30	N90786502	Bolt	2
31	1K0253463AF	Bracket	1
32	1K0254708GX	Particulate filter	1
33	04L253115A	Seal	1
34	1K0253725	Clamp	1

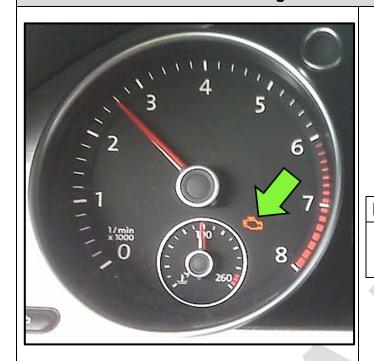
- Check for illumination of the MIL <arrow>.
  - If MIL is illuminated, STOP, obtain GFF diagnostic log, create an ATA ticket and contact the Audi Technicians Helpline.
  - If MIL is not illuminated, continue work procedure.

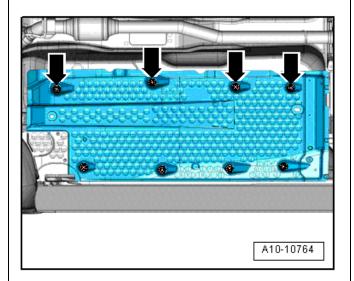
- Open hood.
- Raise vehicle on hoist.
- Unscrew nuts -arrows- and pull underbody cladding down slightly.

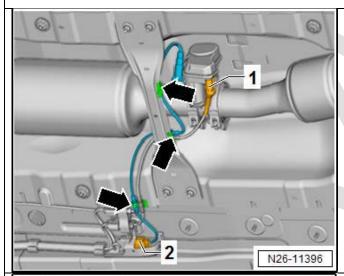
- Disconnect »brown« connector for oxygen sensor after catalytic converter -G130- -2-.
   Remove plug from retainer.
- Open fasteners for heat shield and pull connector
   -1- off exhaust door control unit -J883- and thread wiring out of retainers -arrows-.

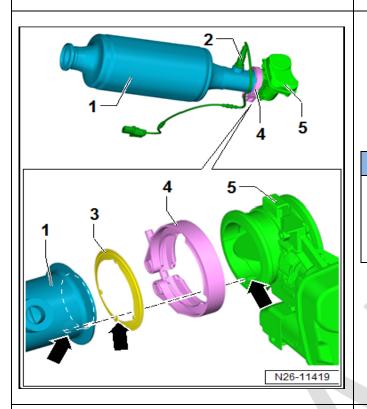
- Screw new oxygen sensor after catalytic converter -G130- -2- into new NOx storage catalytic converter -1- and tighten to 52 Nm using socket, 22 mm -T10491-.
- Set new exhaust door control unit -J883- -5- with new seal -3- on NOx storage catalytic converter -1-. Note notches -arrows-.

Renew all clamps and seals. The clamps before and after the exhaust door control unit are narrower than the clamp connecting the particulate filter to the NOx storage catalytic converter. Ensure that they are correctly allocated.

- Position clamp 1K0 253 725 B -4- and tighten to 7 Nm.
- Place NOx storage catalytic converter together with exhaust door control unit -J883- with new seals in installation position. Note notches at rear connection.

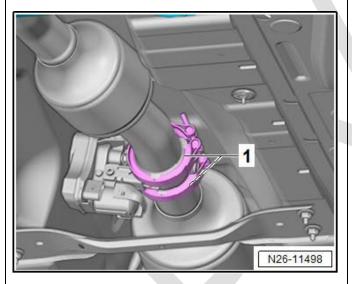
• Position all clamps -1- so that they will not collide with underbody.

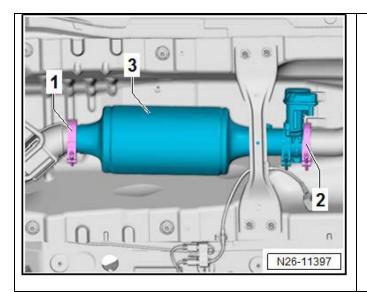
- Set clamp 1K0 253 725 B -2- in place and engage and torque to 7 Nm.
- Set clamp 1K0 253 725 -1- in place and engage. Then tighten to 7 Nm.

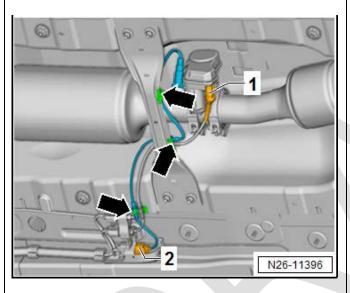
- Connect »brown« connector for oxygen sensor after catalytic converter -G130- -2- and attach to bracket.
- Push connector -1- onto exhaust door control unit. Secure lines in retainers -arrows-.

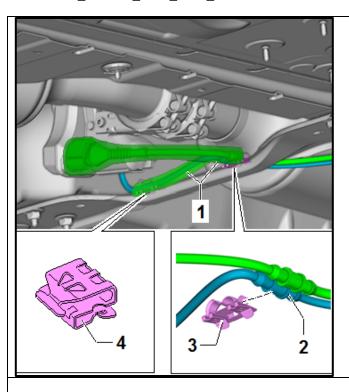
- Wrap new heat insulation mats -1- around wiring and close fasteners.
- Place wires -2- in clips -3- and -4-.

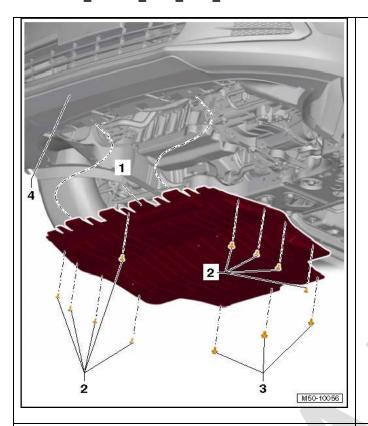
- Remove bolts -2- and -3-.
- Pull noise insulation -1- back, out of front bumper cover -4-.

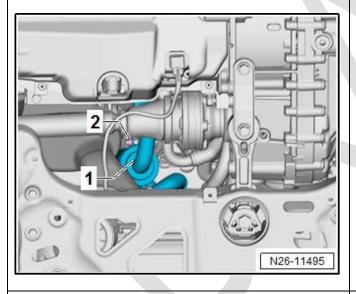
- Remove nut -2- from exhaust gas recirculation filter -1- from below using 13 mm ratchet box wrench (e. g. Snap-on OEXRM13).
- Wrap tape around the tip of a long screwdriver (e.g. Snap-on SDD162 No.2).

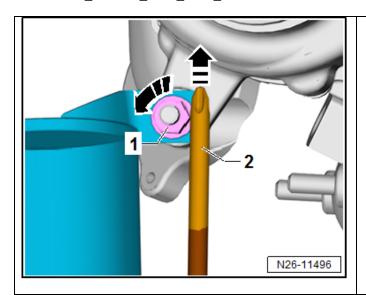
Apply screwdriver -2- on side of nut -1- and unscrew nut while simultaneously pressing up on nut.

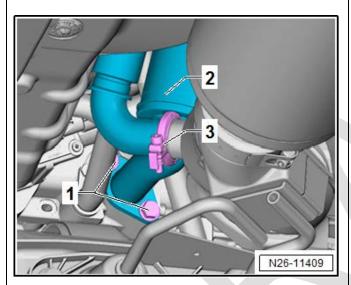
- Open clamp -3- and remove it.
- Remove bolts -1- and remove exhaust gas recirculation filter -2-.

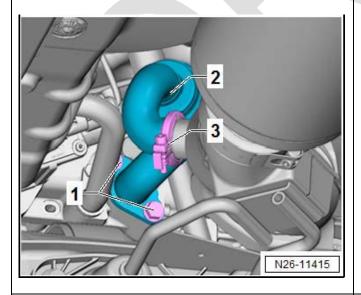
- Set new exhaust gas recirculation filter -2- with new seals in place, screw in bolts -1- and tighten to 9 Nm.
- Position clamp -3- and tighten to 3.5 Nm.

Description	Part number
EGR Filter	1K0.253.120.B
Seal	03G.131.547.H
Seal	1K0.253.115.AG
Clamp	1K0.253.725.F

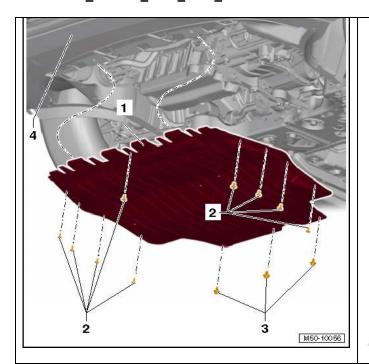
- Push noise insulation -1- forward into front bumper cover -4-.
- Screw in bolts -2- and new bolts -3- and tighten as follows:
  - o Bolt -2-: 2 Nm
  - o Bolt -3-: 6 Nm (renew)

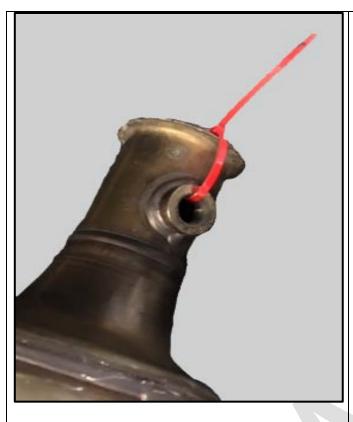
Install the validation strap to the NOx catalytic converter <as shown> to confirm that the proper part is being returned for core.

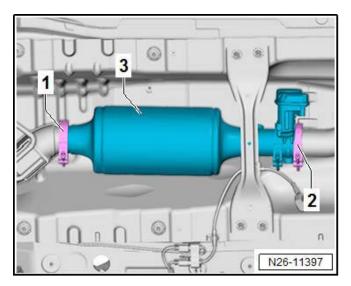
Loosen clamps <1 and 2> and remove NOx storage catalytic converter together with exhaust door control unit -J883-.

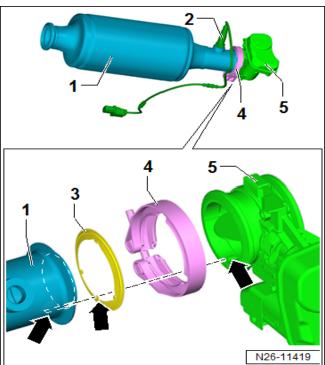
- Screw new oxygen sensor after catalytic converter -G130- <2> into new NOx storage catalytic converter <1> and tighten to 52 Nm using socket, 22 mm -T10491-.
- Set new exhaust door control unit -J883- <5> with new seal <3> on NOx storage catalytic converter <1>. Note notches <arrows>.

Renew all clamps and seals. The clamps before and after the exhaust door control unit are narrower than the clamp connecting the particulate filter to the NOx storage catalytic converter. Ensure that they are correctly allocated.

- Position clamp 1K0 253 725 B <4> and tighten to 7 Nm.
- Place NOx storage catalytic converter together with exhaust door control unit -J883- with new seals in installation position. Note notches at rear connection.

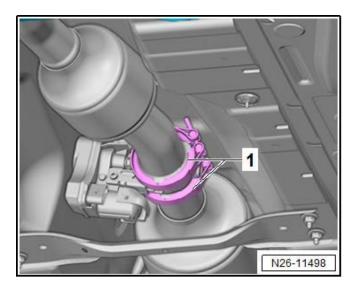
• Position all clamps <1> so that they will not collide with underbody.

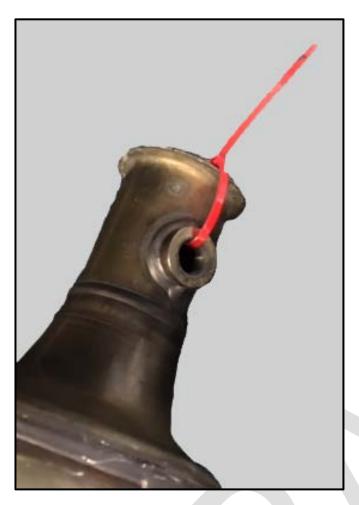
Install the validation strap to the NOx catalytic converter <as shown> to confirm that the proper part is being returned for core.

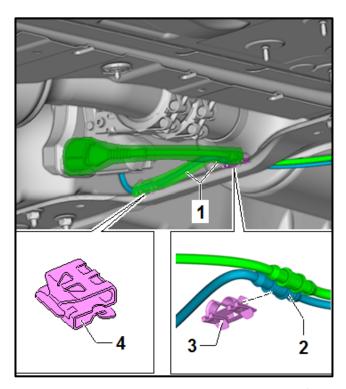
- Wrap new heat insulation mats <1> around wiring and close fasteners.
- Place wires <2> in clips <3 and 4>.

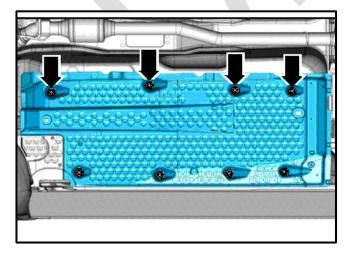
Press underbody cladding upward and tighten nuts <arrows> to 2 Nm.

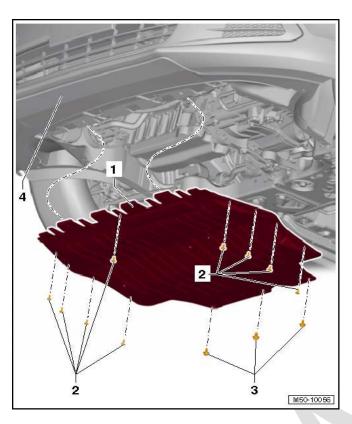
- Remove bolts <2 and 3>.
- Pull noise insulation <1> back, out of front bumper cover <4>.

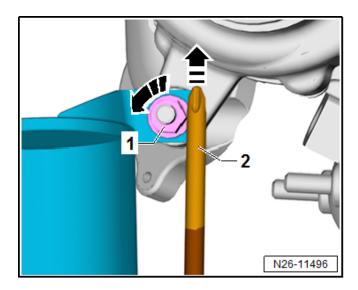
Apply screwdriver <2> on side of nut <1> and unscrew nut while simultaneously pressing up on nut.

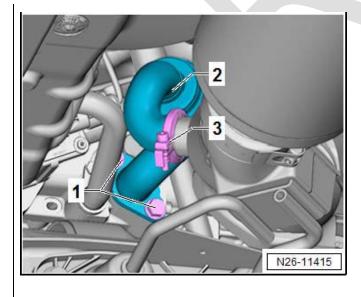
- Set new exhaust gas recirculation filter <2> with new seals in place, screw in bolts <1> and tighten to 9 Nm.
- Position clamp <3> and tighten to 3.5 Nm.

Description	Part number
EGR Filter	1K0.253.120.B
Seal	03G.131.547.H
Seal	1K0.253.115.AG
Clamp	1K0.253.725.F

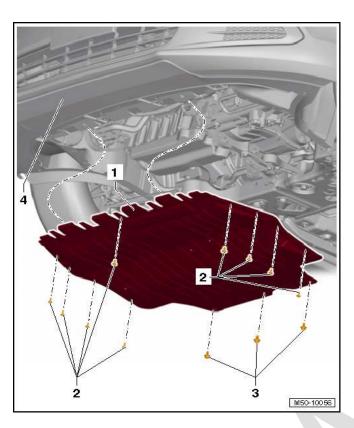
- Push noise insulation <1> forward into front bumper cover <4>.
- Screw in bolts <2> and new bolts <3> and tighten as follows:
  - o Bolt <2>: 2 Nm
  - Bolt <3>: 6 Nm (renew)

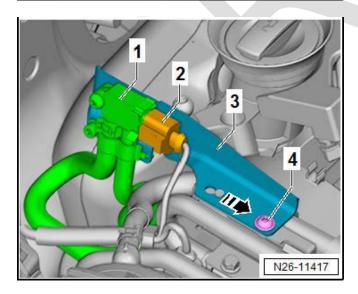
- Pull connector <2> off differential pressure sensor -G505- <1>.
- Remove securing bolt <4>, remove bracket <3> with differential pressure sender -G505- <1> in <direction of arrow> and move aside. Control lines remain connected.

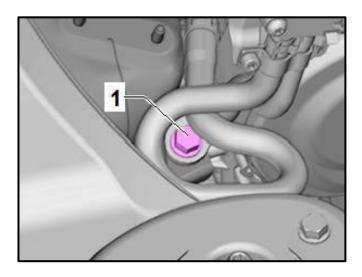
Unscrew securing bolt <1> on upper bracket for particulate filter.

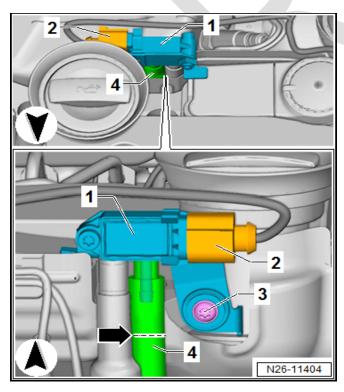
- Open fasteners on heat insulation <1> for exhaust pressure sensor 1 -G450-.
- Open heat insulation <2> for wiring and remove.

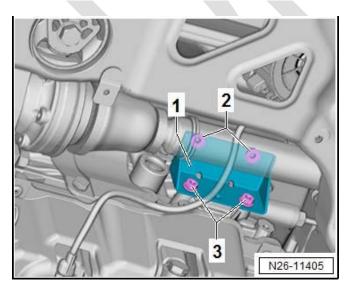
Unscrew bolts <1> and remove heat shield for right drive shaft.

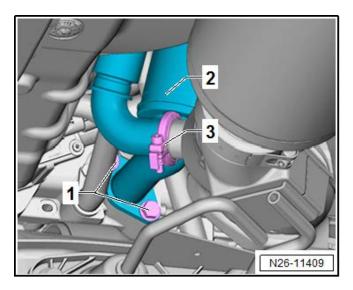
Unscrew securing nuts above bracket <2> with ratchet wrench -T10384-. In some cases, the bracket cannot be removed until the particulate filter has been detached.

• Remove nuts <2 and 3> and remove lower bracket for particulate filter <1>.

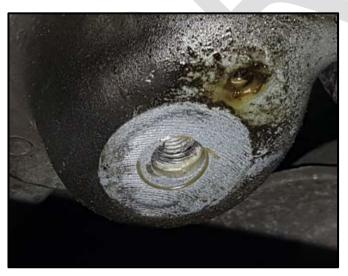
• To fix the position of the subframe, the locating pins -T10096- must be screwed one at a time into positions <1, 2, 3 and 4>.

The locating pins -T10096- may be tightened only to max. 20 Nm, or the threads of the locating pins will be damaged.

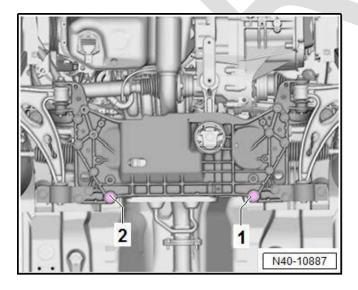
For clarity of illustration, the following steps are shown without the engine and gearbox jack.

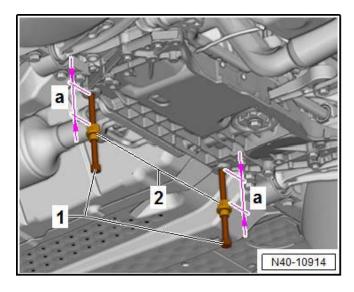
Unscrew bolts <1 and 2>.

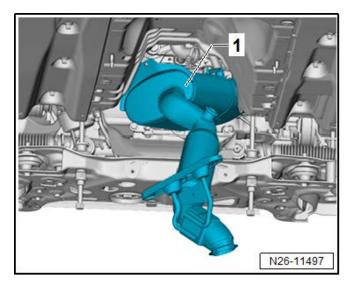
- Remove hexagon nuts <2> from front tunnel cross-piece <1> and remove tunnel cross-piece.
- Remove securing clamp between NOx storage catalytic converter and exhaust door control unit -J883-.

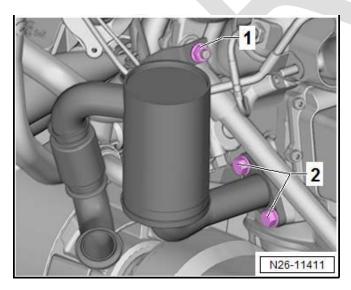
Open clamp <2> and remove exhaust door control unit <1>.

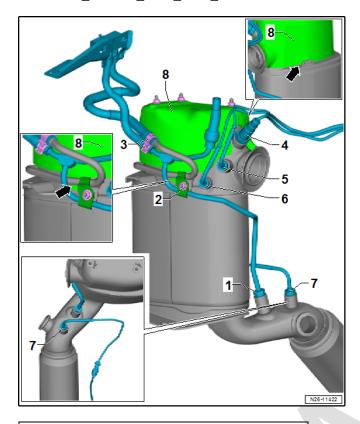
Remove nut <1> and bolts <2>, and remove exhaust gas recirculation filter.

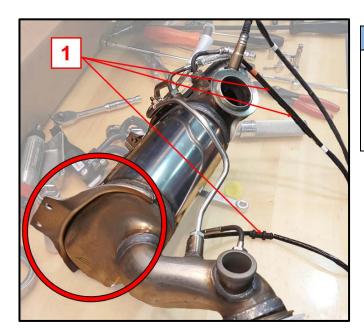
When installing the exhaust gas temperature senders to the DPF, it is possible to install the sensors <1> in the wrong locations. Sensors installed in the wrong positions will not function properly. Pay attention to the sensor color coding <circle> when installing sensors into the DPF.

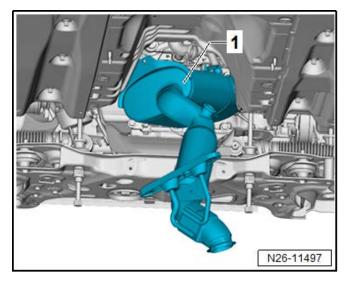
- Do not bend flexible joint more than 10°.
- Install flexible joint free of tension.
- Take care not to damage wire mesh on flexible ioint.
- The flexible joint must be secured with transportation lock -T10404- to prevent overstretching.
- Always hold the particulate filter by the heavy casing when transporting or handling it.
  - Loosen nut <arrow> for bracket <1> on top of cylinder head a few turns.

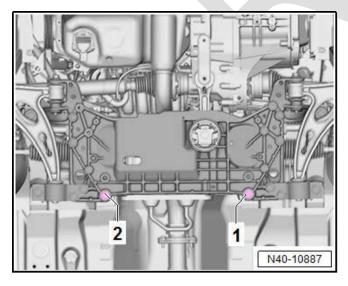
- Raise subframe about 5 cm, screw in bolt <1> and tighten to 3 Nm.
- Carefully raise subframe to installation position taking locating pins into consideration.

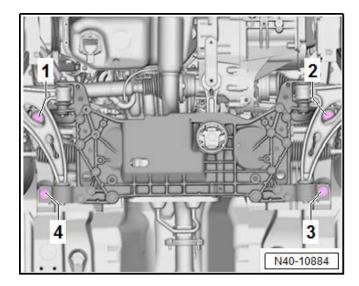
Remove spindles 3346/2, screw in new bolts (M12 x 110 mm) at positions <1 and 2>, tighten to 50 Nm and turn an additional 120°.

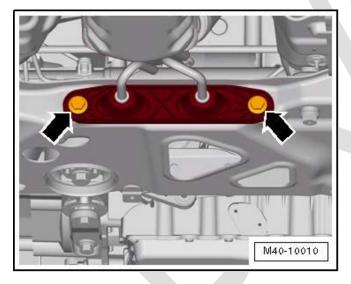
- Tighten bolts <arrows> securing exhaust system bracket to subframe to 23 Nm.
- Remove transport and protective packaging from flexible joint for particulate filter.

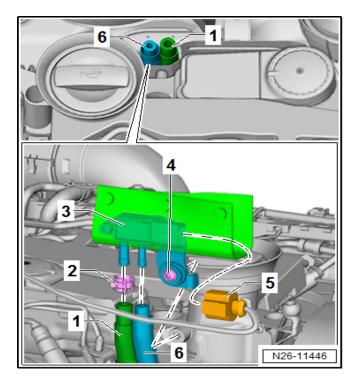
For greater clarity, exhaust pressure sensor 1 -G450is shown here from behind (perspective of plenum chamber bulkhead).

- 1 Remove bolt <1>.
- 2 Remove and dispose of old pressure sensor <6>.
- 3 Insert new pressure sensor <2> into bracket
   <3>
- 4 Screw in bolt <1> and tighten to 10 Nm.
- 5 Guide bracket with pressure sensor through openings in new heat shield <4>.

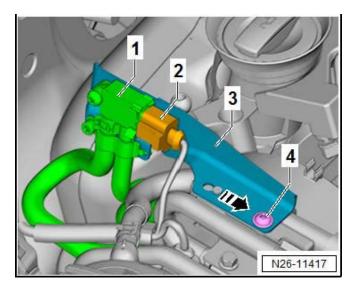
- Close fasteners on heat insulation mat <1> around exhaust pressure sensor 1 -G450-.
- Wrap new heat insulation mat <2> around wiring and close fasteners.

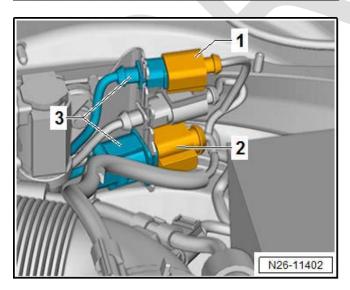
- Connect »brown« connector for exhaust gas temperature sender 3 -G495- <2> and secure behind bracket.
- Thread lines into brackets <1> on plenum chamber bulkhead and on turbocharger.

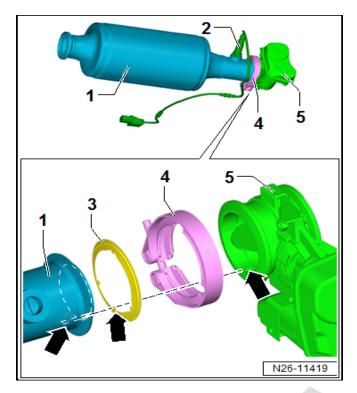
Screw oxygen sensor after catalytic converter
 -G130- <2> into NOx storage catalytic converter
 <1> and tighten to 52 Nm.

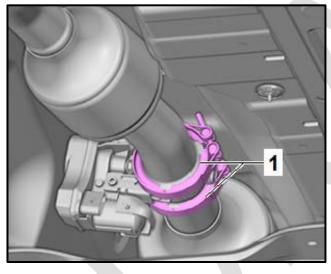
- Place NOx storage catalytic converter together with exhaust door control unit -J883- with new seals in installation position. Note notches at rear connection.
- Position all clamps <1> so that they will not collide with underbody.

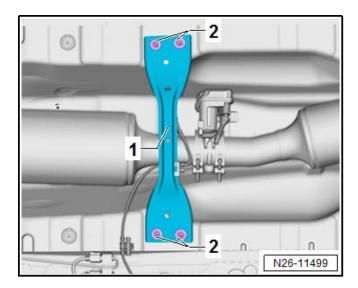
• Set front tunnel cross-piece <1> in place, screw on hexagon nut <2> and tighten to 20 Nm.

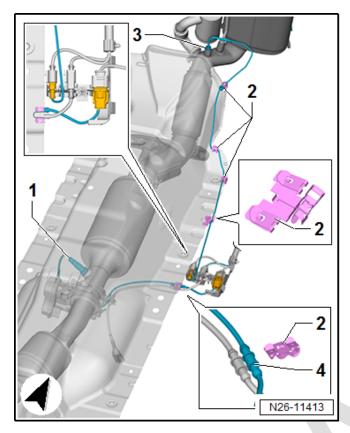
#### Routing electrical wiring on underbody:

Place electrical wiring from oxygen sensor after catalytic converter -G130- <1> and exhaust gas temperature sender 4 -G648- <3> in clips <2> on heat shield as shown. Connect connector and secure in bracket.

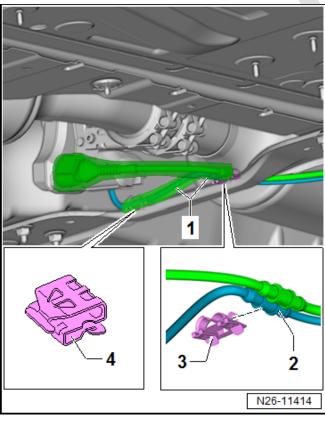
- Wrap new heat insulation mats <1> around wiring and close fasteners.
- Place wires <2> in clips <3 and 4>.

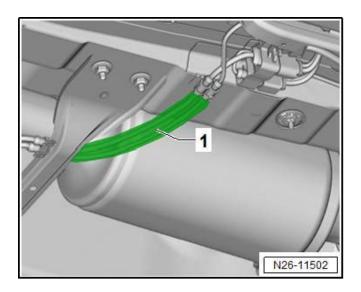
• Wrap new heat insulation mat <1> around wiring and close fasteners.

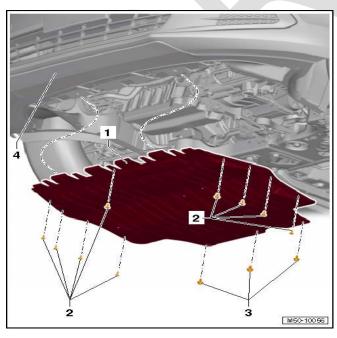
- Push noise insulation <1> forward into front bumper cover <4>.
- Screw in bolts <2> and new bolts <3> and tighten as follows:
  - o Bolt <2>: 2 Nm
  - Bolt <3>: 6 Nm (renew)

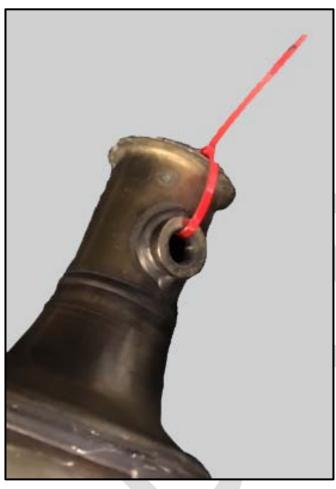
Install the validation strap to the NOx catalytic converter <as shown> to confirm that the proper part is being returned for core.

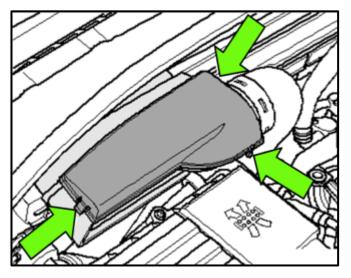
- Switch ignition off and remove key
- Open hood.
- Carefully remove engine cover.
- Release the tabs <arrows> and remove the cover on the air intake.

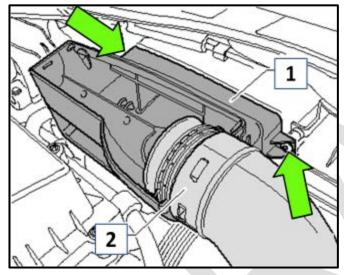
• Remove the screws <arrows> for the air intake guide <1> and pull the guide hose <2> out of the air intake guide <1>.

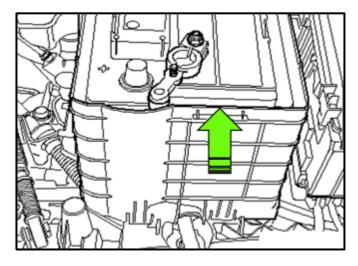
• Remove the battery cover in the direction of <arrow>.

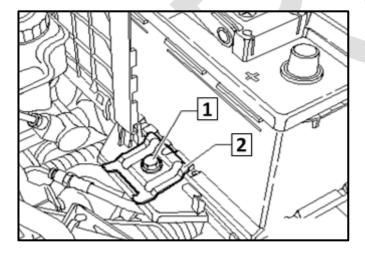
Remove the bolt <1> and then remove the clamping plate <2>.

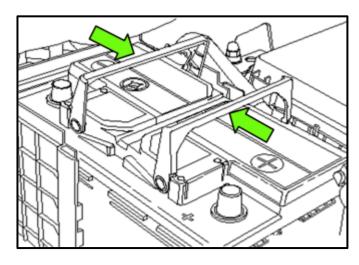
• Fold up the handles <arrows> and remove the battery.

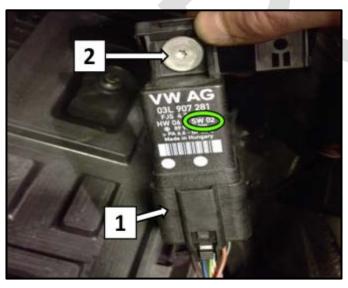
- Inspect the software version of the glow plug control module <circle>.
  - If the software version <circle> is "SW 02,"
     DO NOT REPLACE the glow plug control module.
  - If the software version <circle> is not "SW 02," REPLACE the glow plug control module with part number (03L 907 281).
- If replacing the glow plug control module, disconnect electrical connector <1>, remove screw with bracket <2> and reinstall onto new glow plug control module.

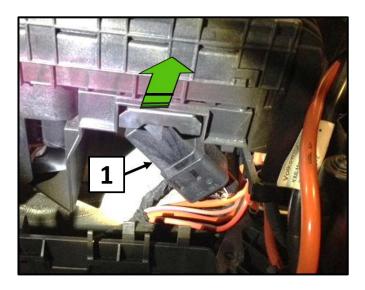
To install, slide glow plug control module <1> into position underneath left engine compartment Ebox <in direction of arrow>.

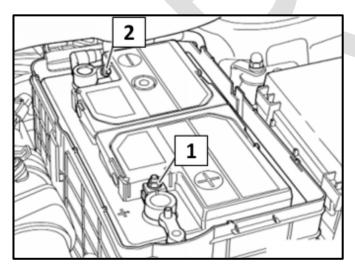
- First, reconnect positive cable to positive terminal on battery and torque screw <1> to 6Nm.
- Second, reconnect negative cable to negative terminal on battery and torque screw <2> to 6Nm.
- Reinstall battery cover

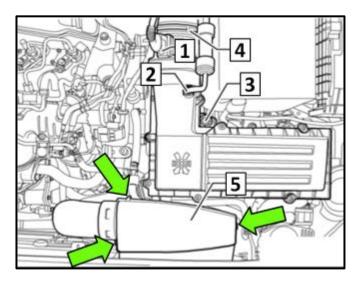
- · Reinstall the air filter housing
- Tighten the bolt <3> for the lower air filter housing.
- Reinstall the intake tube and close the clamp <4>.
- Reconnect the Mass Airflow Sensor -G70connector <1> and the vacuum line <2>.

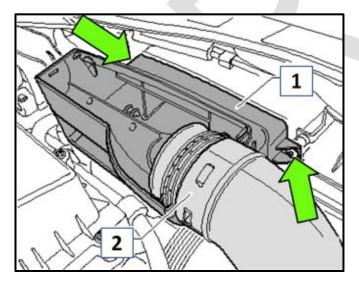
Reinstall the air intake guide <1> and air intake guide hose <2>, then tighten the screws <arrows>.

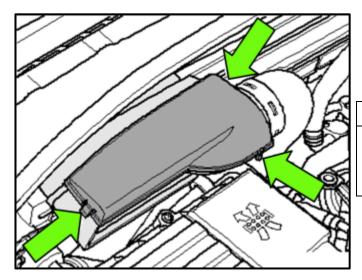
- Reinstall the cover on the air intake and secure tabs <arrows>.
- Reinstall engine cover.
- Switch on ignition

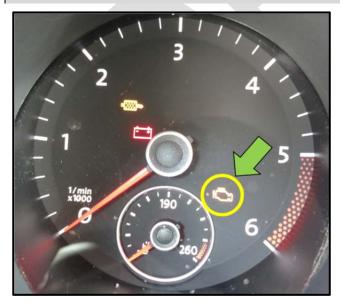
- Check for illumination of the MIL <arrow>.
  - If MIL is illuminated, STOP, obtain GFF diagnostic log, create an ATA ticket and contact the Audi Technicians Helpline.
  - o If MIL is not illuminated, continue work procedure.

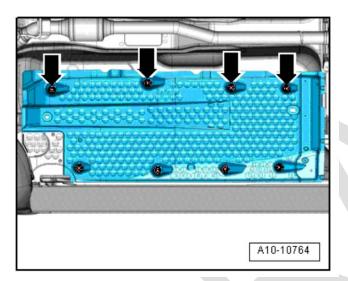
- Open hood.
- Raise vehicle on hoist.
- Unscrew nuts <arrows> and pull underbody cladding down slightly.

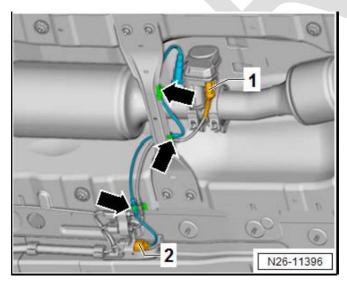
- Disconnect »brown« connector for oxygen sensor after catalytic converter -G130- <2>.
   Remove plug from retainer.
- Open fasteners for heat shield and pull connector
   off exhaust door control unit -J883- and thread wiring out of retainers <arrows>.

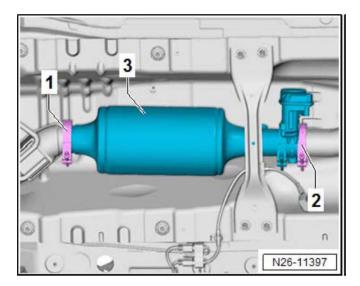
Loosen clamps <1 and 2> and remove NOx storage catalytic converter together with exhaust door control unit -J883-.

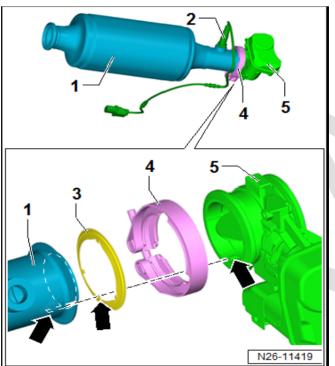
- Screw new oxygen sensor after catalytic converter -G130- <2> into new NOx storage catalytic converter <1> and tighten to 52 Nm using socket, 22 mm -T10491-.
- Set new exhaust door control unit -J883- <5> with new seal <3> on NOx storage catalytic converter <1>. Note notches -arrows-.

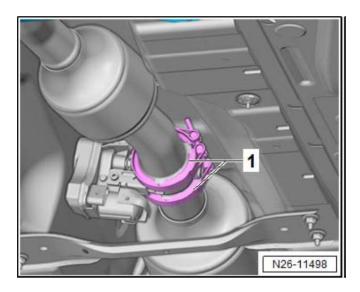
• Position all clamps <1> so that they will not collide with underbody.

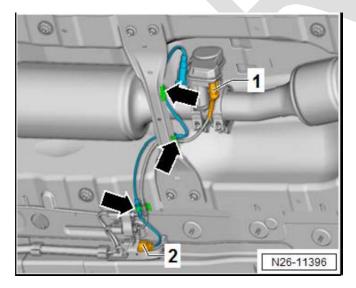
- Connect »brown« connector for oxygen sensor after catalytic converter -G130- <2> and attach to bracket.
- Push connector <1> onto exhaust door control unit. Secure lines in retainers <arrows>.

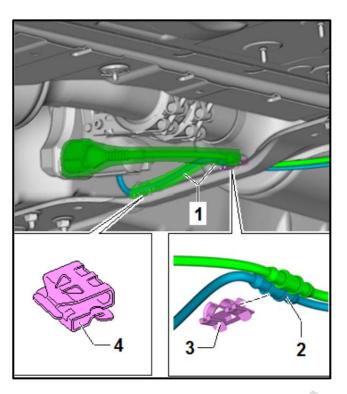
- Wrap new heat insulation mats <1> around wiring and close fasteners.
- Place wires <2> in clips <3 and 4>.

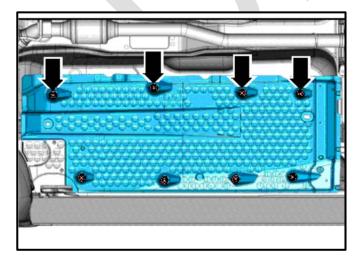
Press underbody cladding upward and tighten nuts <arrows> to 2 Nm.
